Refacing Method 101

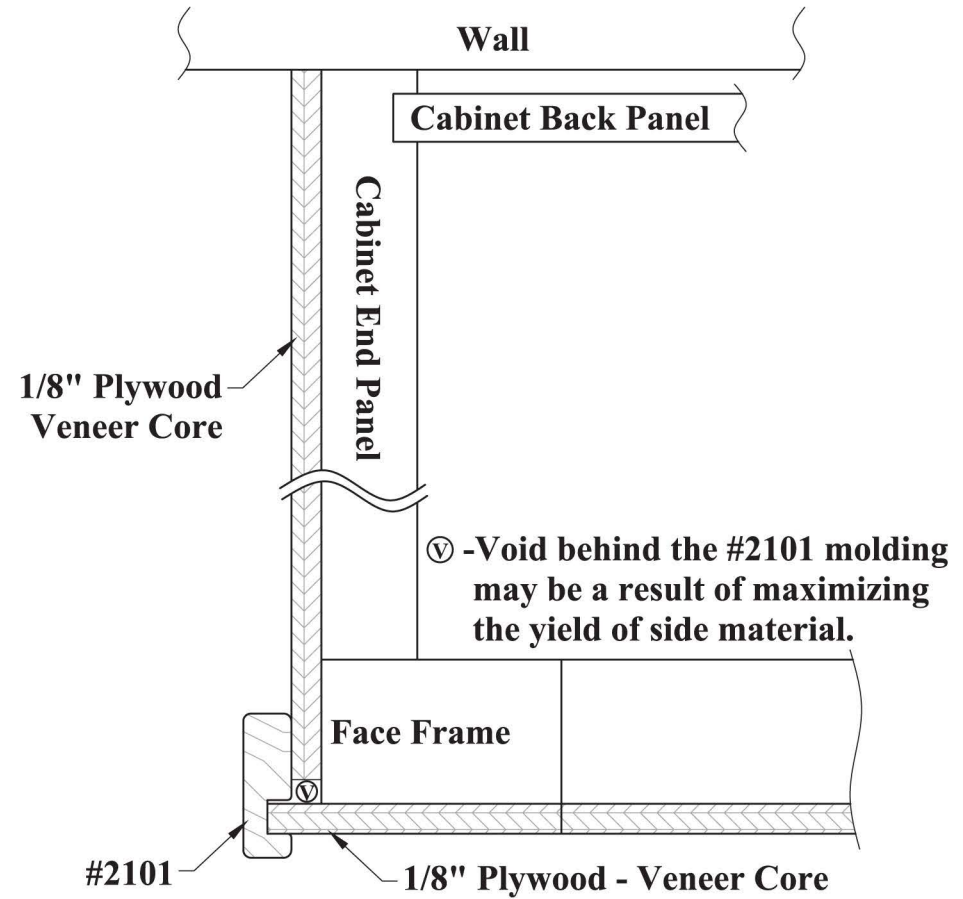
Shown with Cabinet Scribe Removed
